**Freeze-thaw cycling with de-icing salt immersion, EN 13687-1
PAGEL V1/160 (0-16 mm)**

Requested by: Alimex Oy

Order VTT-O-176537-16, 24.2.2016

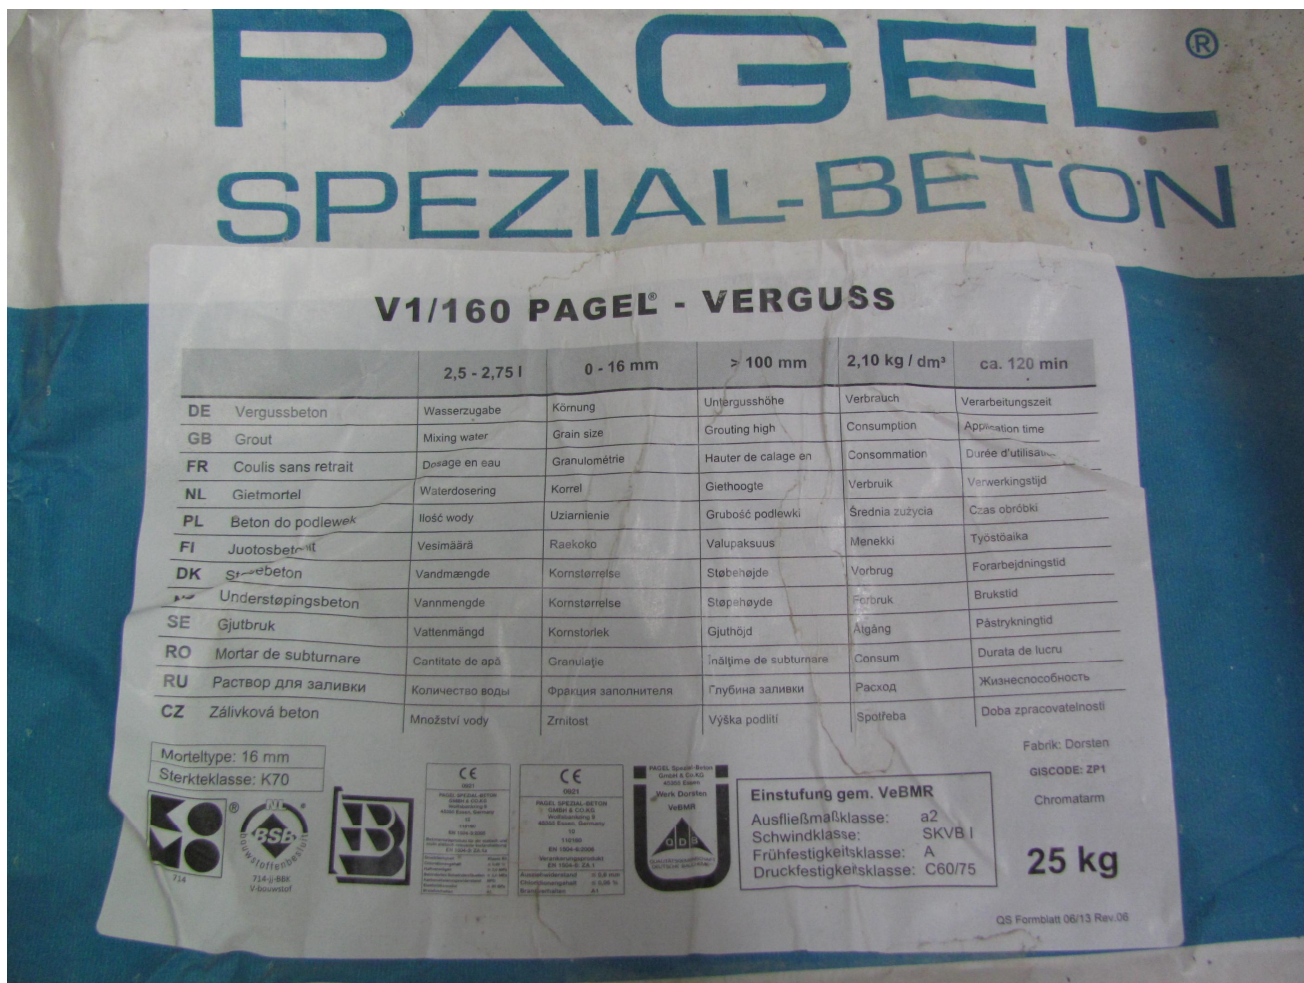
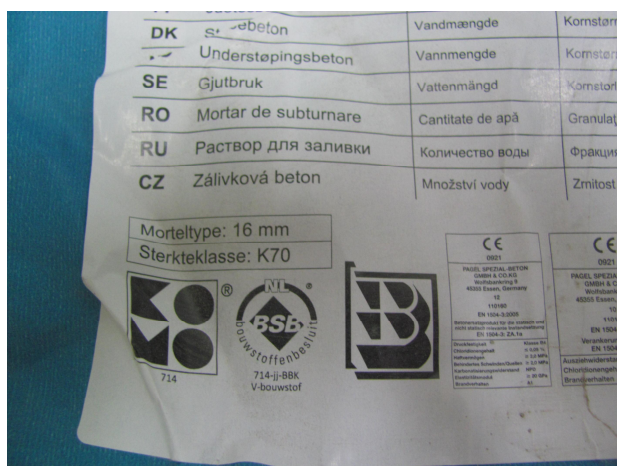
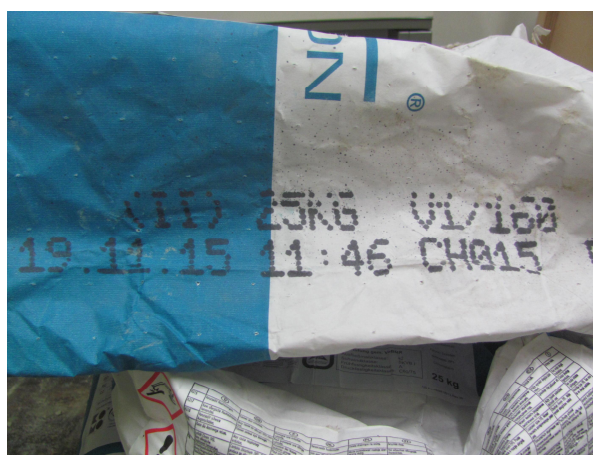
Preparing of the test specimen, molds and surface of the concrete before casting of the repair product.

Samples Concrete test specimens of dimensions 300 x 300 x 100 mm MC(0,40) according to EN 1766 were prepared by VTT Expert Services Ltd on the week 5, 2016. Concrete slabs were cured emerged in water bath for 27 days. Surfaces of the concrete slabs were grit-blasted.

Repair grout PAGEL V1/160 was cast onto the concrete slabs by the customer on 14.3.2016 at VTT Expert Services Ltd, at conditions of temperature $(20 \pm 2)^{\circ}\text{C}$ and relative humidity RH $(60 \pm 5) \%$. Thickness of a repair grout layer on the concrete was approximately 50 mm.

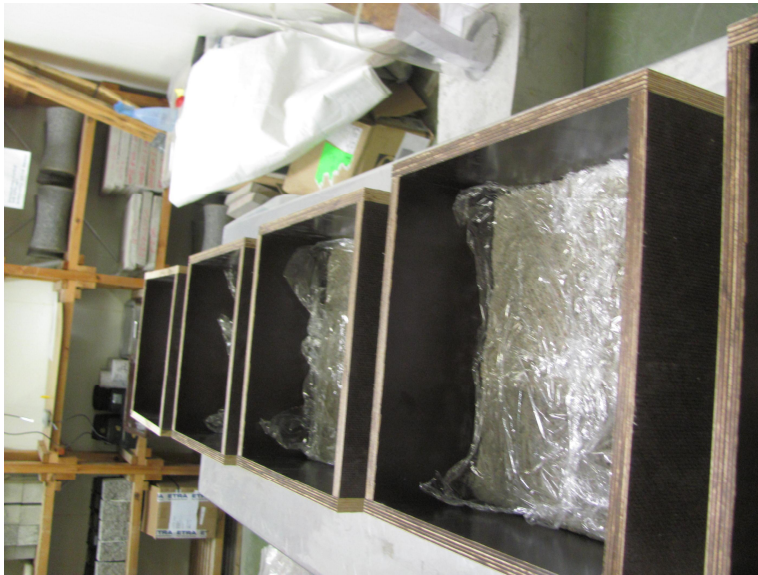
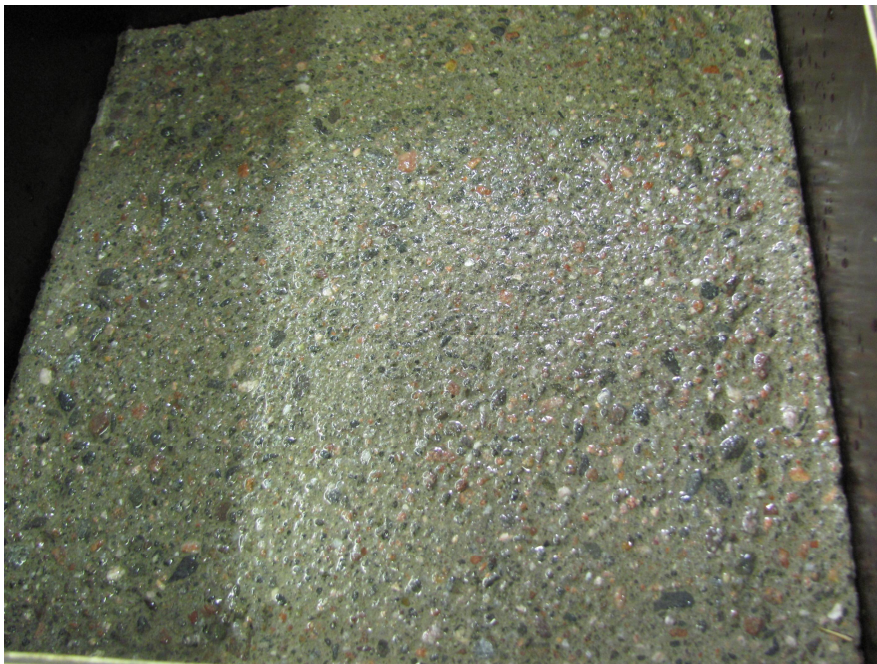
Sealing of the sides and rear of the concrete test specimens.

Samples were edge sealed (all sides and rear of the concrete test specimen) up to 5 mm on to the face of the sample with water proofing.

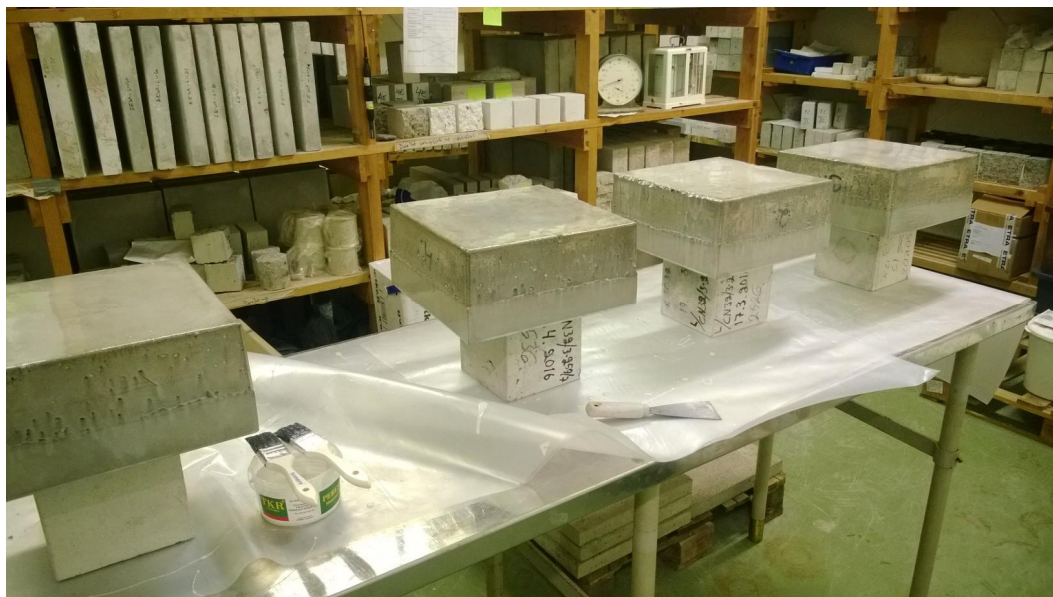
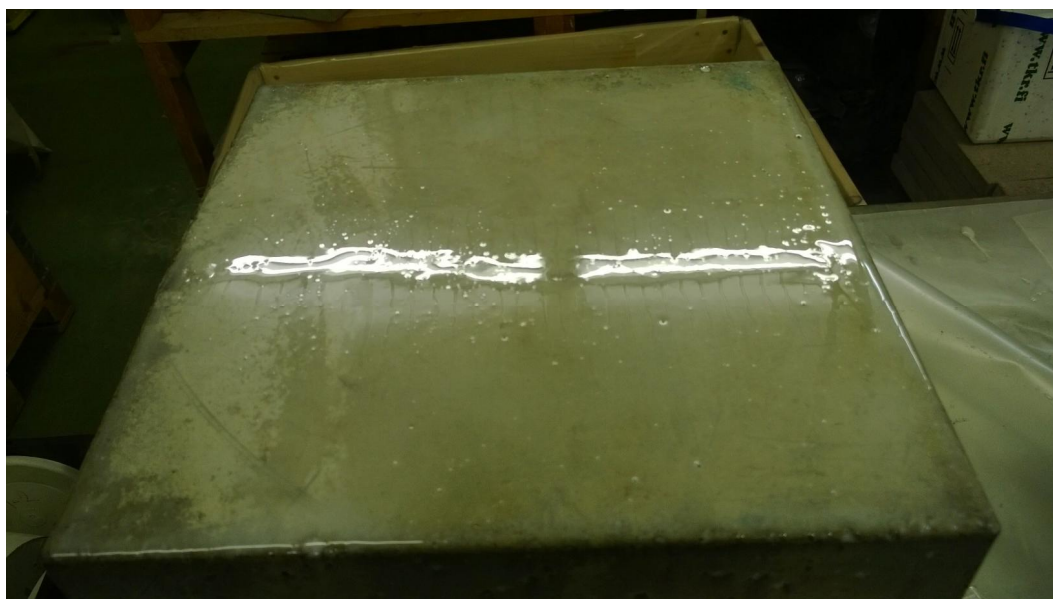
Test procedure: Immersion in the tank containing saturated sodium chloride solution at temperature of $(-15 \pm 2)^{\circ}\text{C}$. Freezing stage.

- immersion to the tank containing saturated sodium chloride solution at a temperature of $(-15 \pm 2)^{\circ}\text{C}$ for 2 h + storage in water tank at temperature of $(21 \pm 2)^{\circ}\text{C}$ for 2 hours

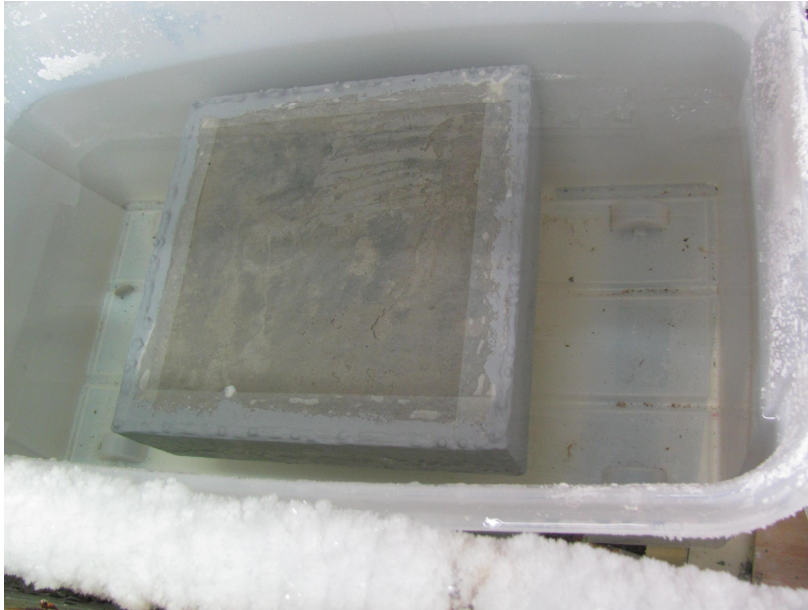
Test procedure: storage in the water tank at temperature of $(21 \pm 2)^{\circ}\text{C}$. Thaw stage.

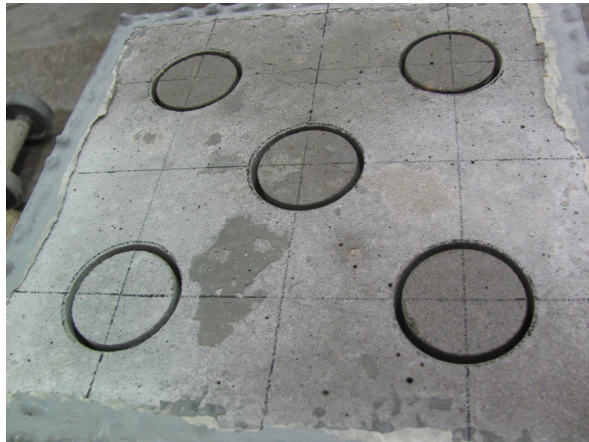
Drilling schema.

Surfaces of the test specimen were cleaned up with steel brush for any loose material. Five cores, \varnothing 50 mm were drilled to the surface up to a depth of (15 ± 5) mm into the concrete substrate, photo in the Appendix 5.

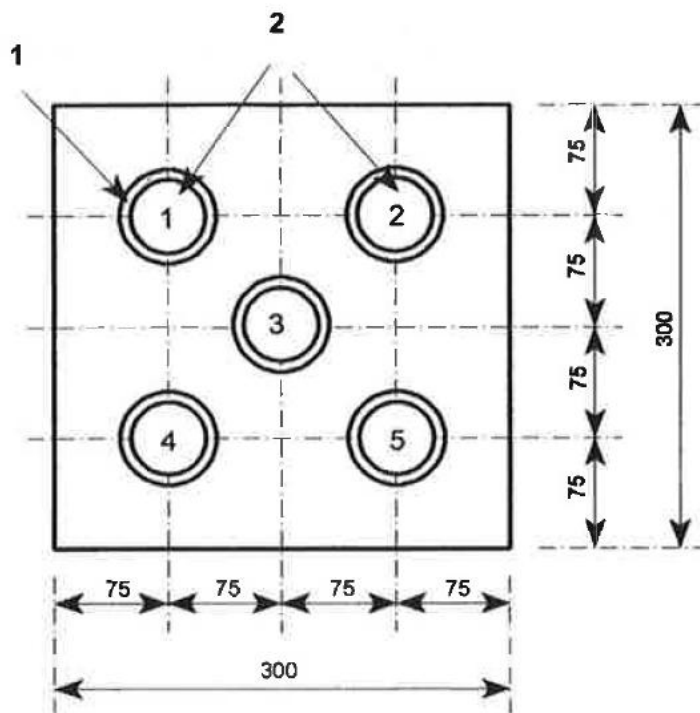
Key

- 1 Annulus around test area, formed by coring
- 2 50 mm diameter steel or aluminium dolly

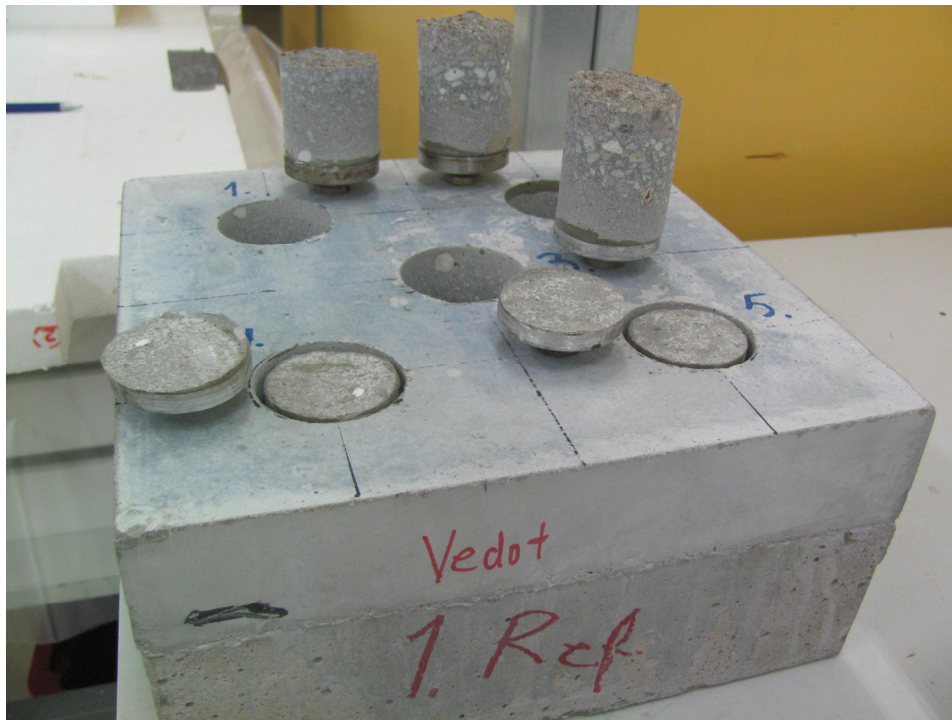
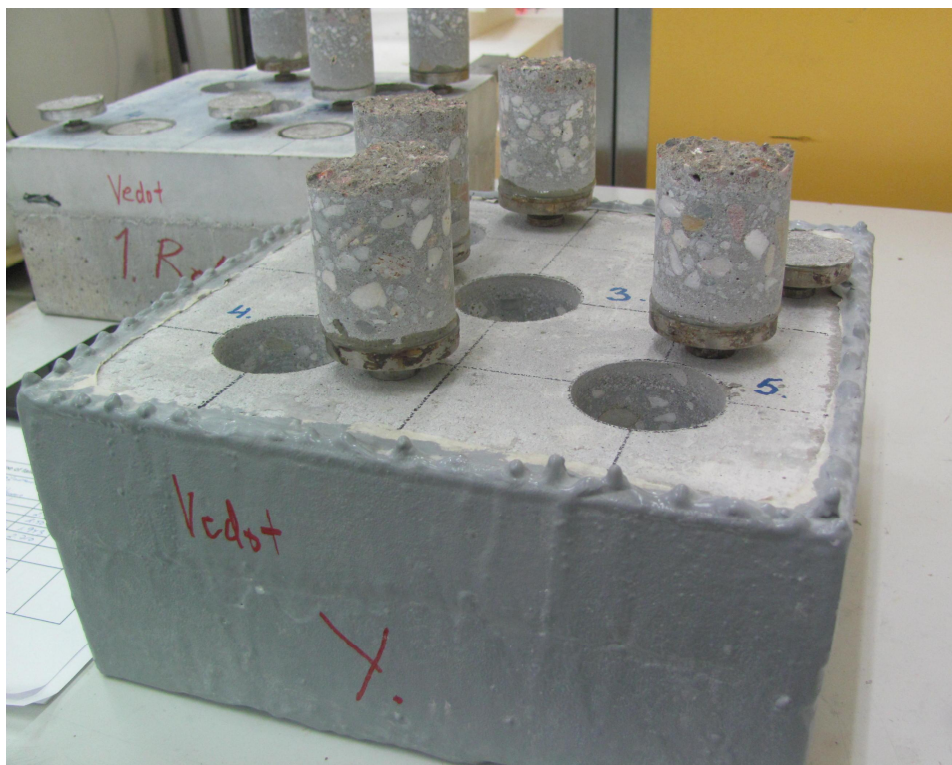
Pull-off strength test.

Dollies (\varnothing 50 mm) were glued with 2-pack Epoxy adhesive on the cores for pull-off test, which was performed with calibrated F15D Easy M 2000, TL 13166, 20.6.2016 pull-off adhesion tester. Loading rate in the test was 100 N/ s. Pull-off tests were performed 21.6-27.6.2016.

As the debonding took place mainly in concrete the results represents the strength of the concrete slabs in the test.
